Study for:  
The Wyoming Business Council  
Wyoming Main Street Program

# 521 Broadway Downtown Building

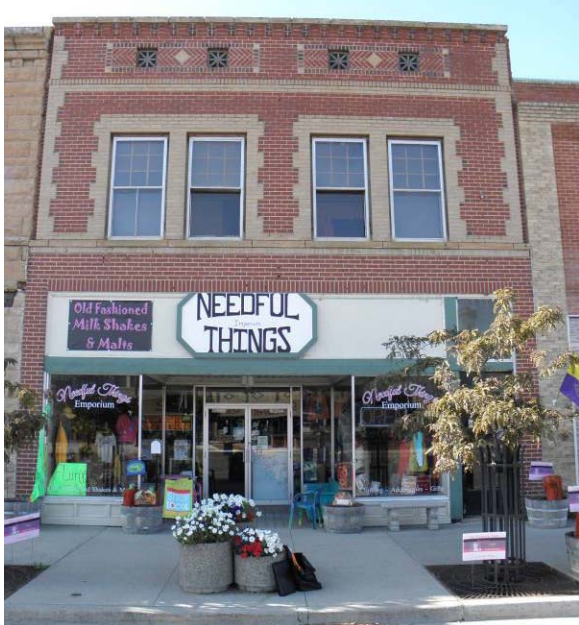
**2015: View of current north façade**

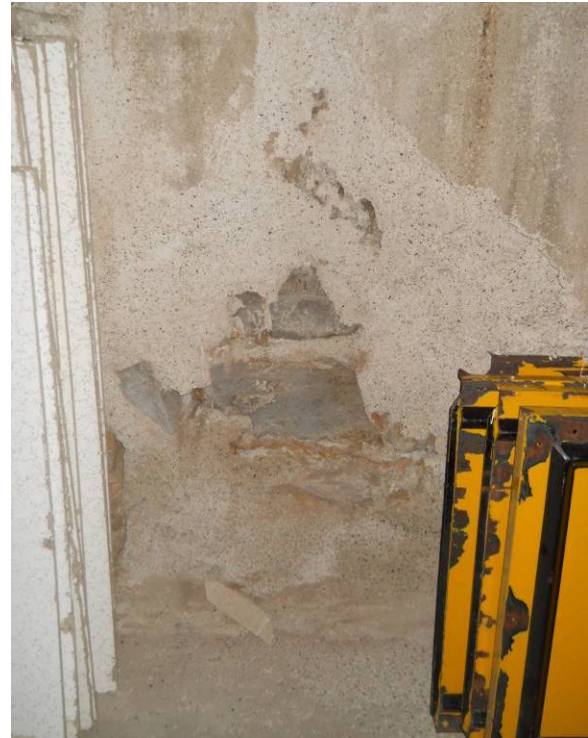
**View of east basement stone wall showing sloughing material**

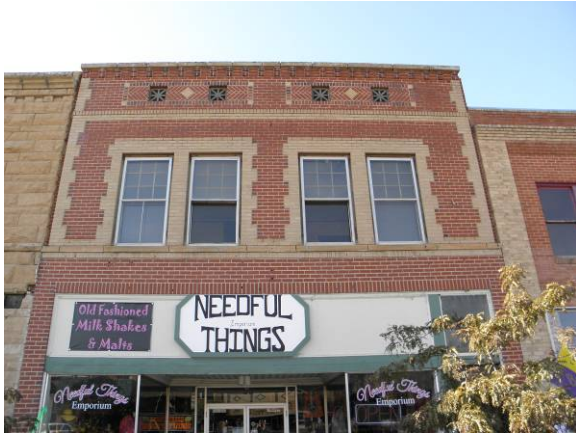
**View of north historic facade fronting Broadway**

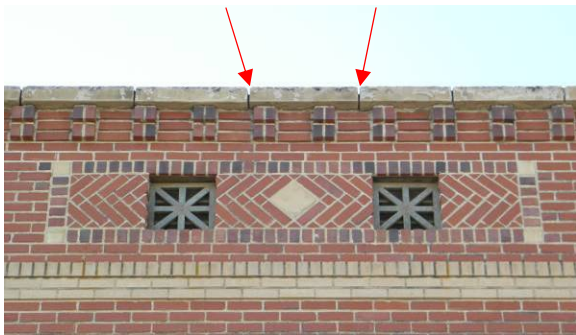
**View of front stone parapet cap with daylight showing through joints**

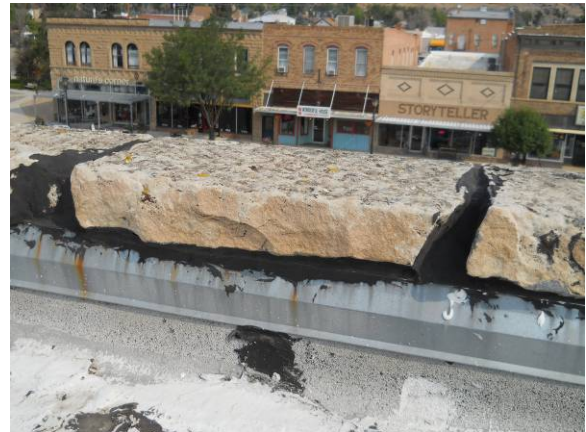
**View of stone parapet cap from the rooftop showing joints not filled completely**

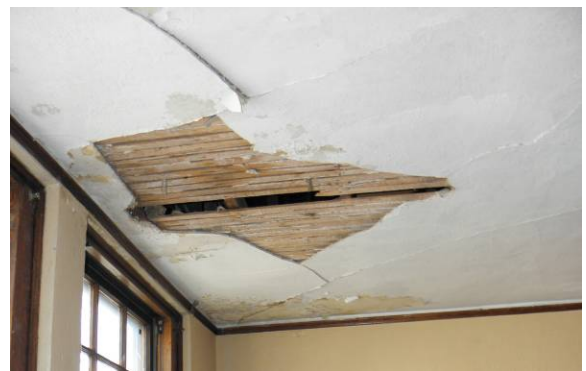
**Typical ceiling damage from water infiltration**

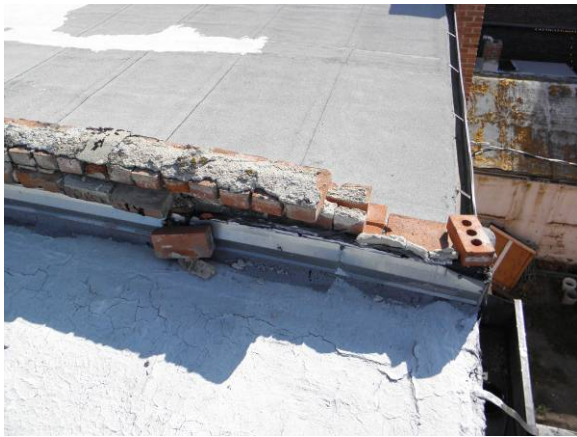
View of an upper east brick parapet

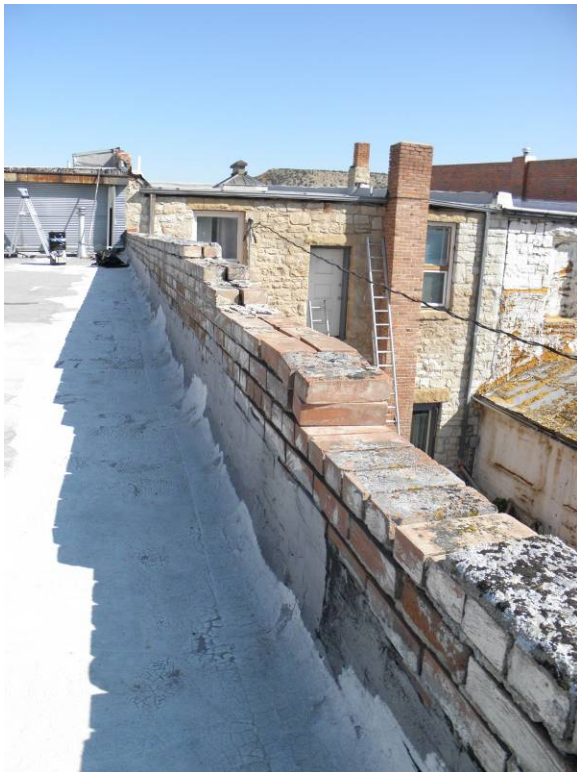
View of lower east brick parapet

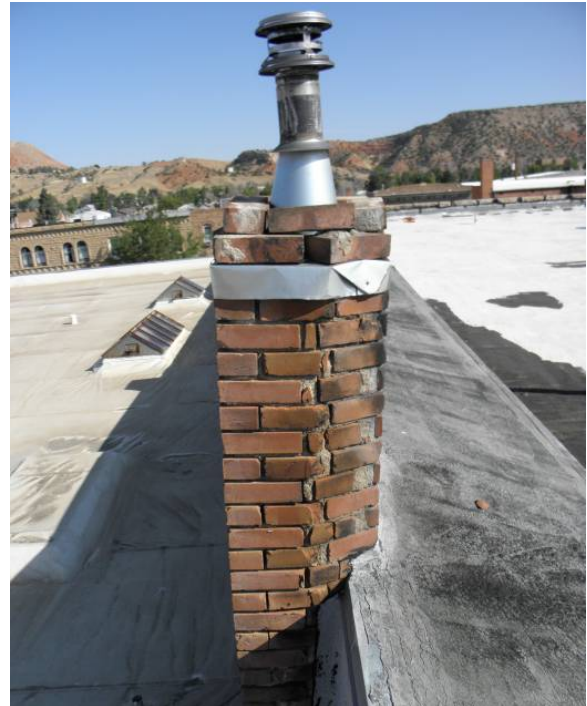
View of chimney with furnace vent - middle west side of the upper roof

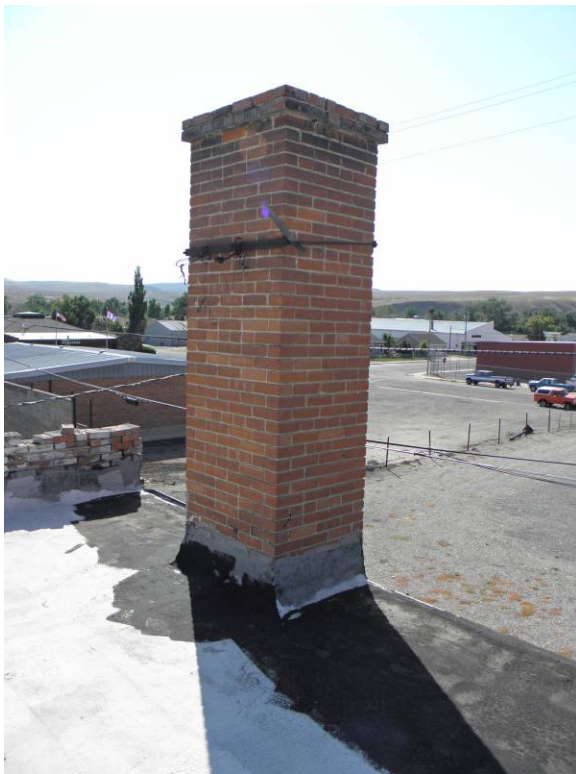
View of south chimney on lower roof

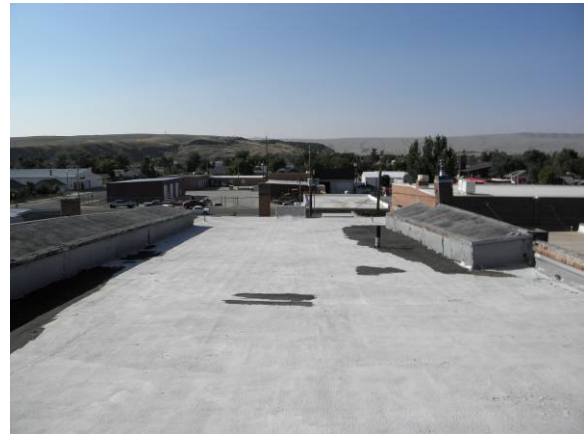
View of upper existing roof looking south

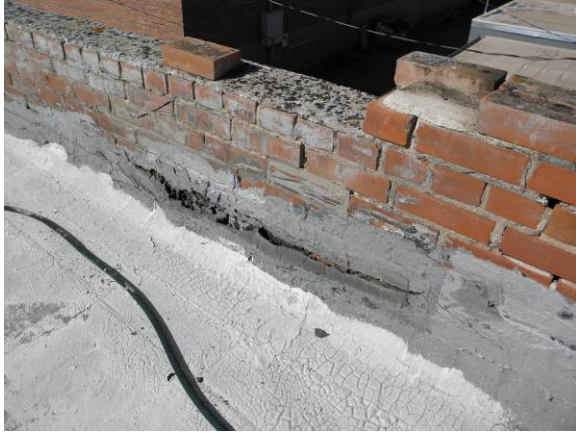
**View of flashing at parapet where it is pulling away and allowing water/moisture infiltration**

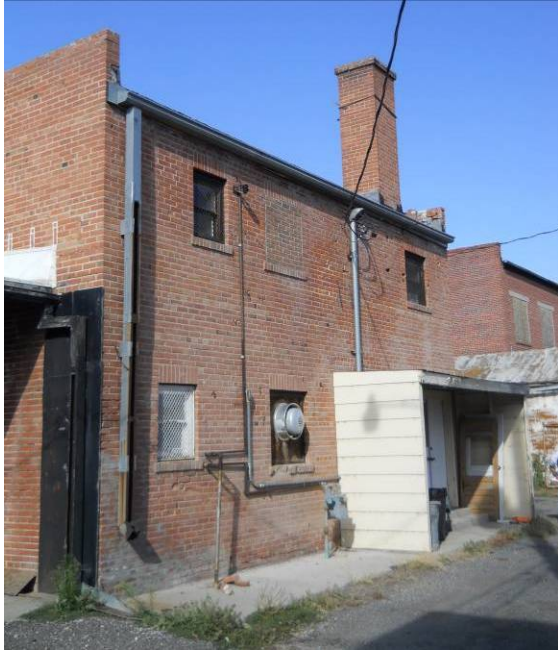
**View of gutter and downspout from lower roof discharging to the ground/alley**

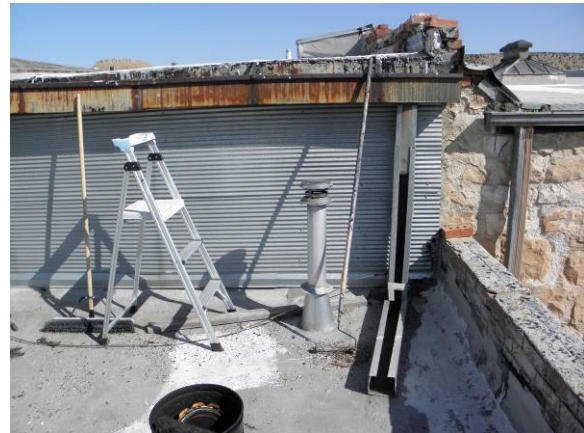
**Gutter on east end of upper roof showing severity of offset between top of roof and top of gutter**

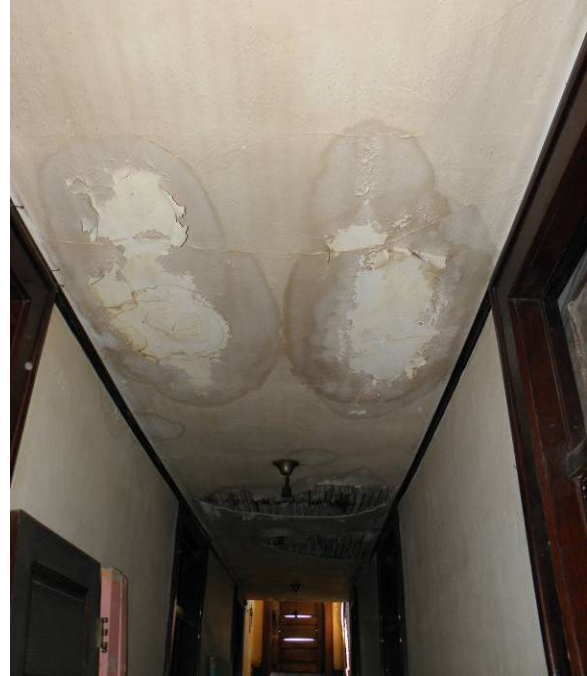
**View of hall ceiling showing damage from water**

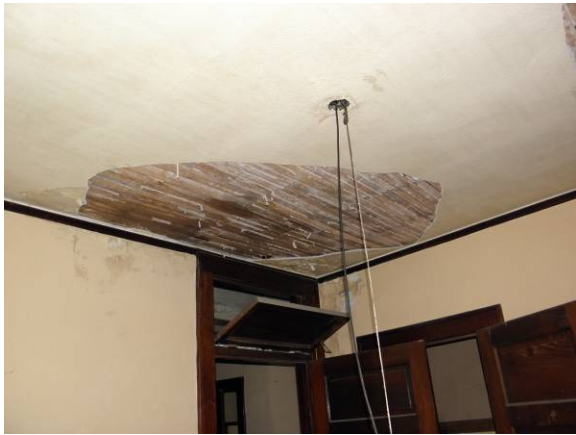
**View of typical ceiling/wall water damage, missing plaster exposing wood lath substrate**

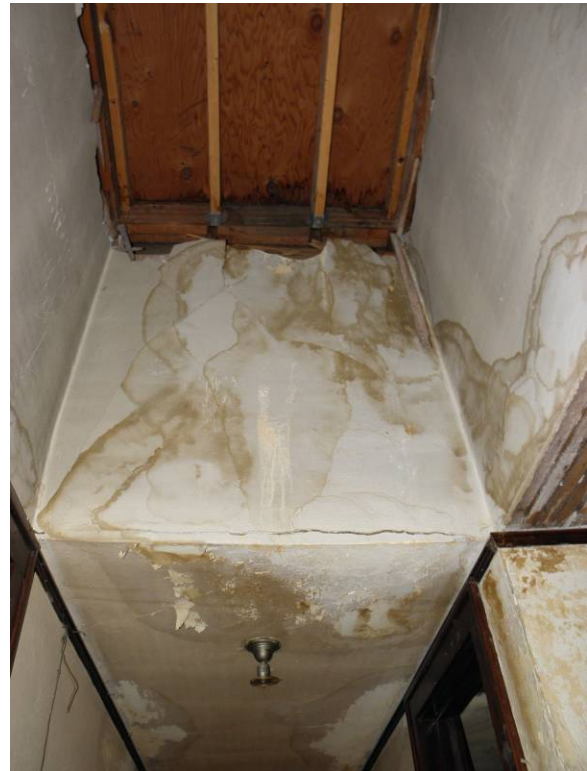
**View of ceiling and wall area near north skylight showing water damage due to water infiltration**

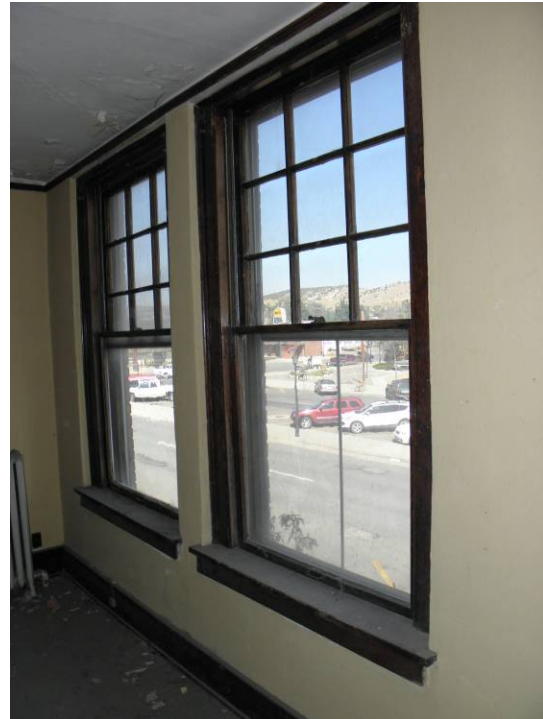
View of north windows

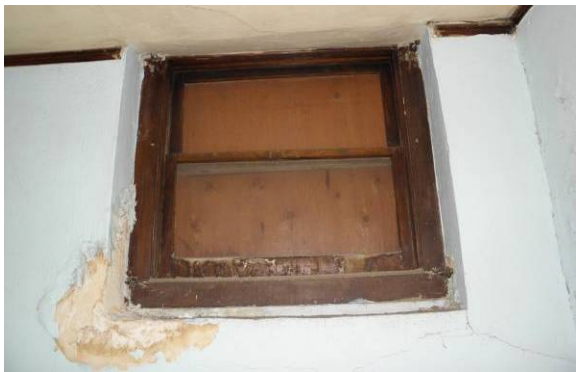
**South window showing water damage**

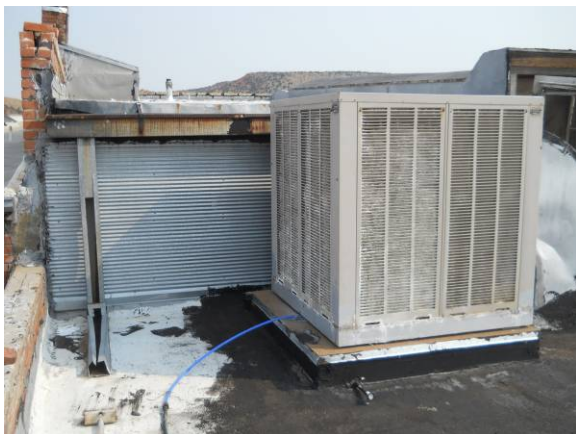
**Exterior view of south window showing plywood and metal covering**

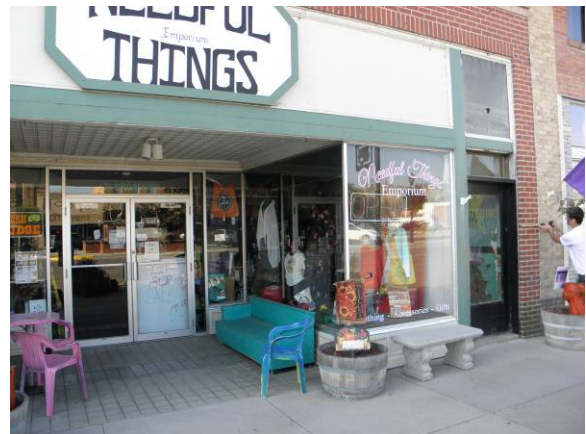
**View of storefront, west door to second floor and transoms above**

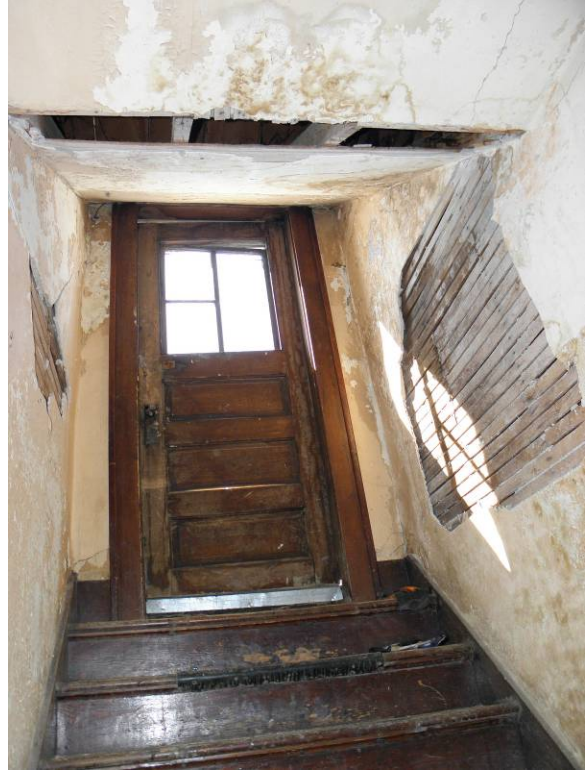
**South door from second floor to roof**

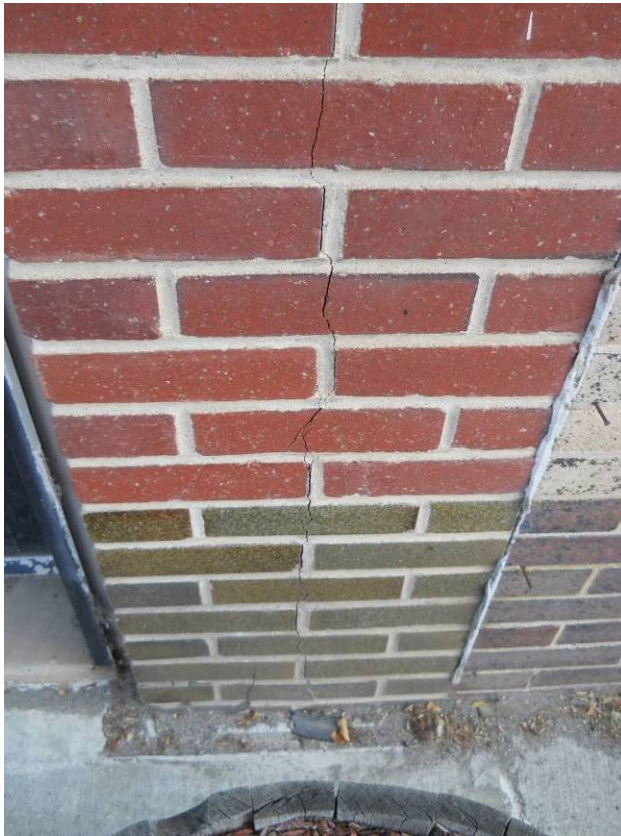
**Minor crack in North façade/West party wall**

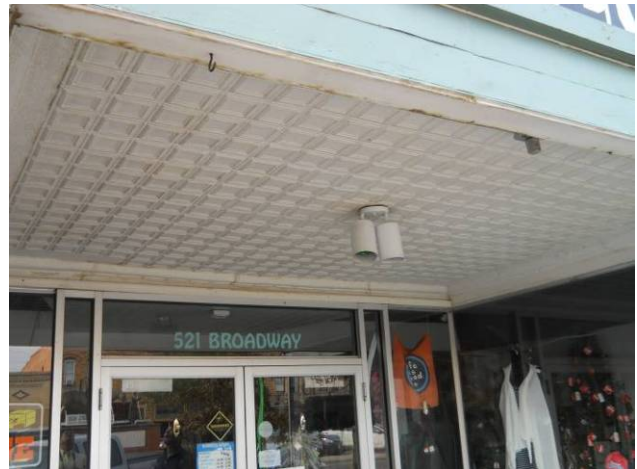
**Existing entrance and tin ceiling**

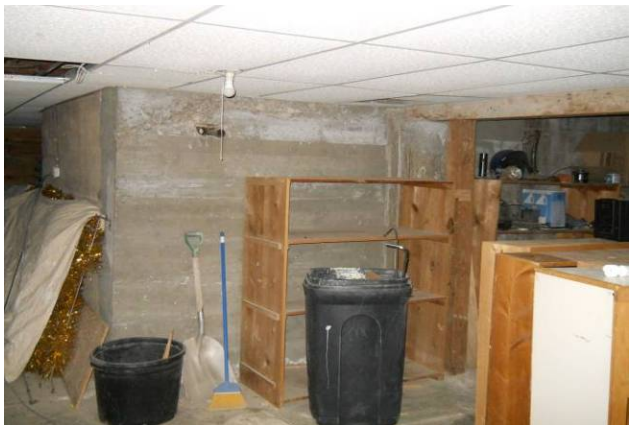
**View of previous building foundation walls looking south**

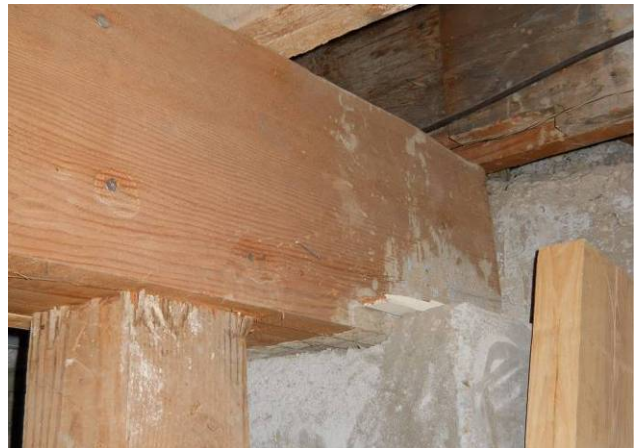
**Structural floor beam connection into foundation wall**

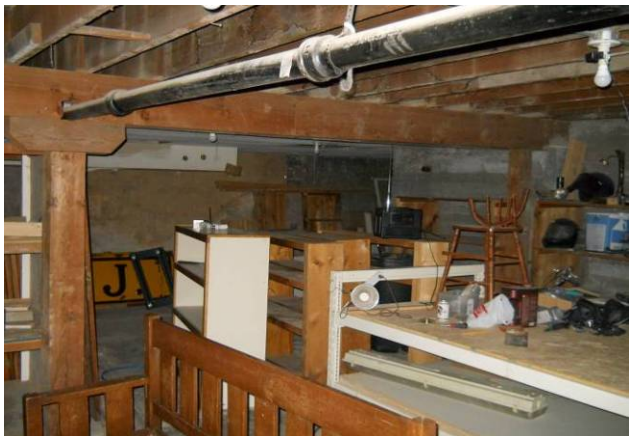
**Central storage looking southeast**

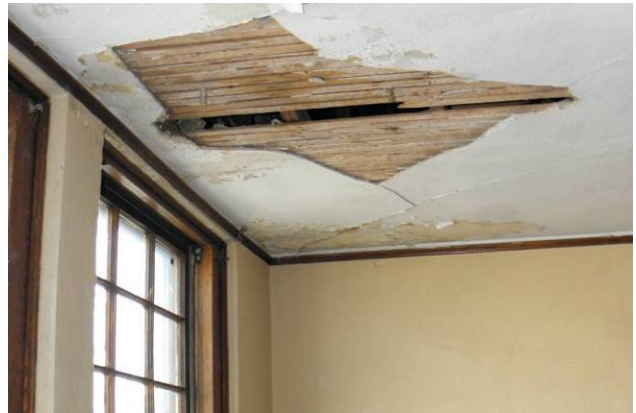
**Ceiling damage in Room #1**

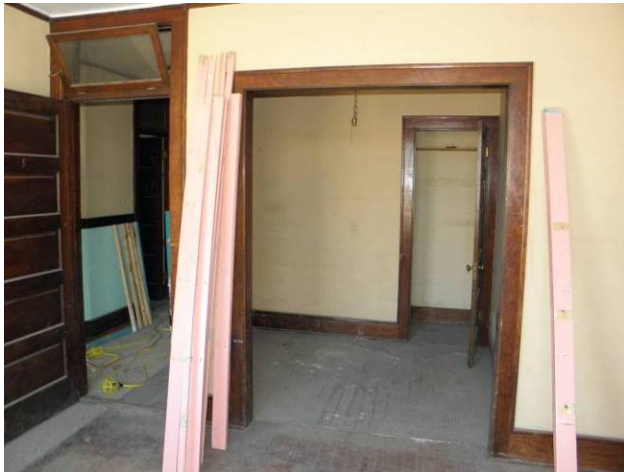
**Room #1 looking southeast toward main corridor**
