Study for:
The Wyoming Business Council
Wyoming Main Street Program

Occidental Hotel

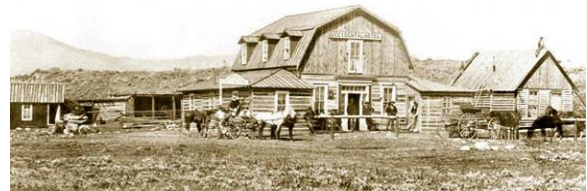
Circa 1880: East facade of original log buildings

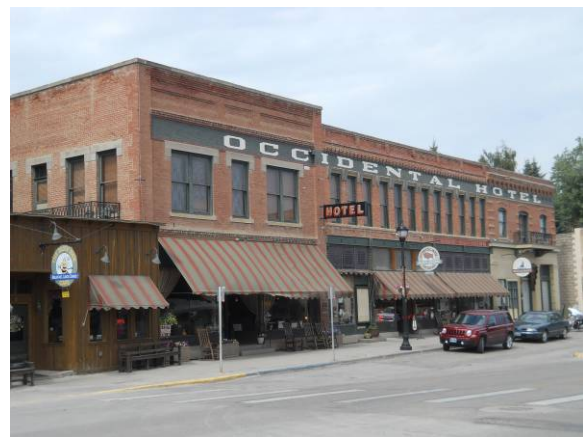
2015: View of current east façade

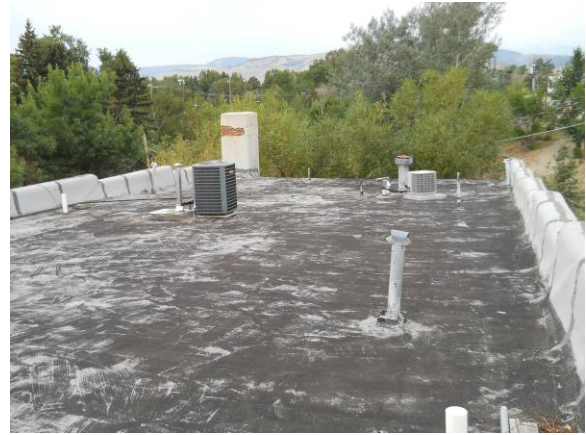
View of north roof looking west, showing existing rolled roofing membrane material

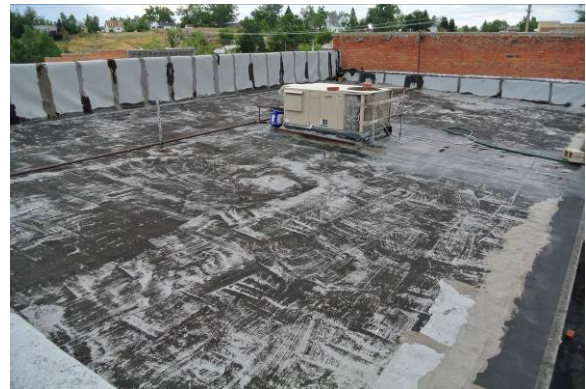
View of middle roof looking south, showing existing rolled roofing membrane material/condition with multiple patches

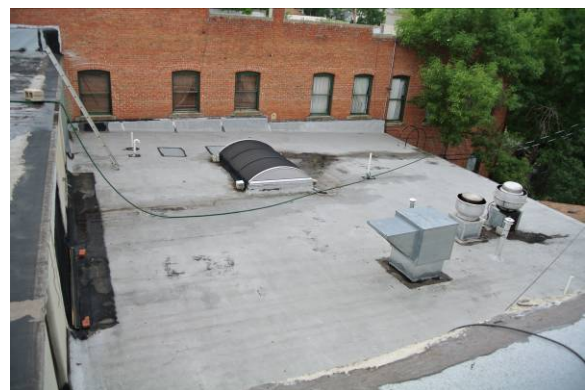
View of middle roof looking south, showing existing rolled roofing membrane material/condition

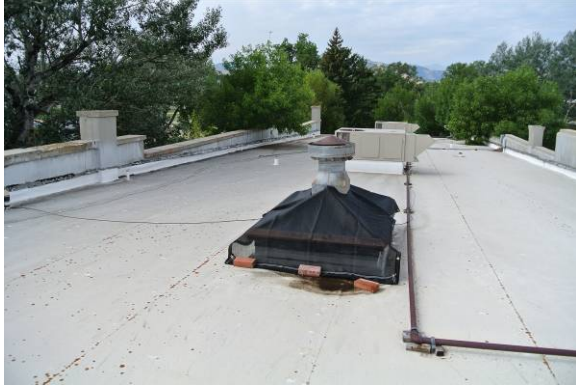
View of south roof looking west, showing existing single-ply membrane roofing material/condition

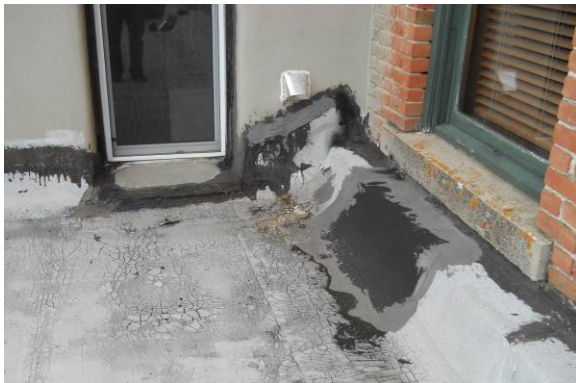
Typical condition of rolled roofing membrane, cracking/ hazing of surfaces, multiple patches, all providing water entry potential

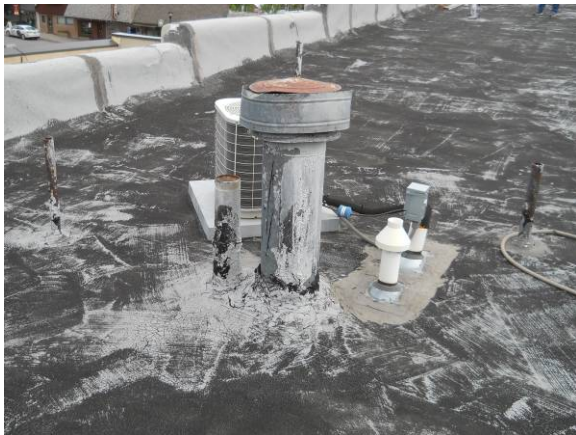
Typical rolled roofing membrane roof penetrations

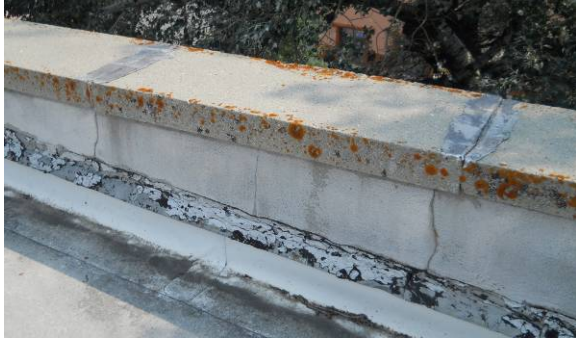
South roof: concrete coping with stucco on backside of parapet with visible cracking and metal flashing underneath

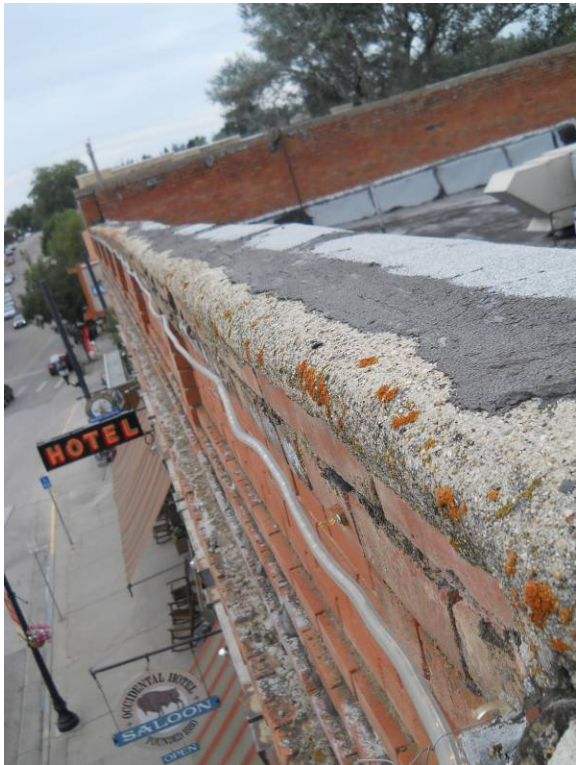
Middle roof: rolled roofing membrane terminating at top middle of parapet with concrete coping

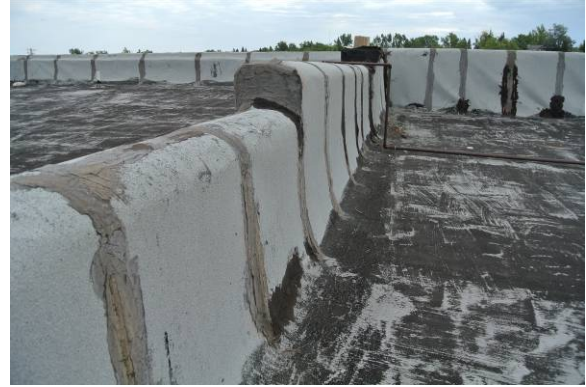
North and Middle roof: rolled roofing membrane over top of parapet wall with stucco finish underneath in most places

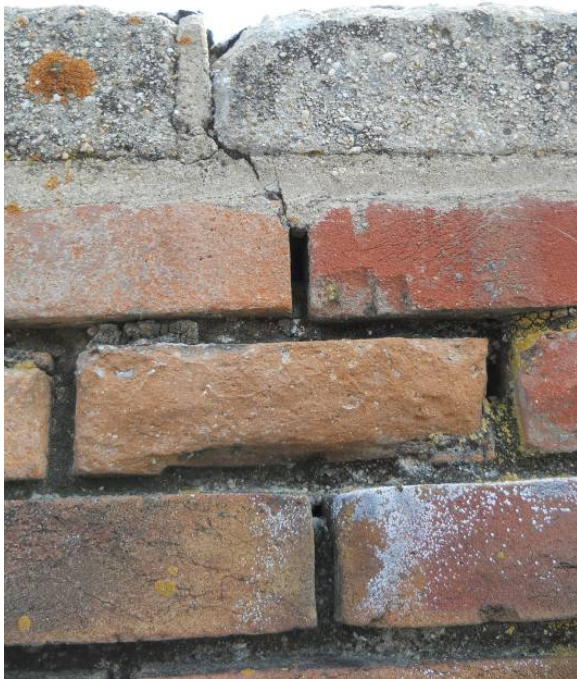
Front facade of south roof parapet showing path of water infiltration through the joint of concrete coping and eroding of brick mortar joints below

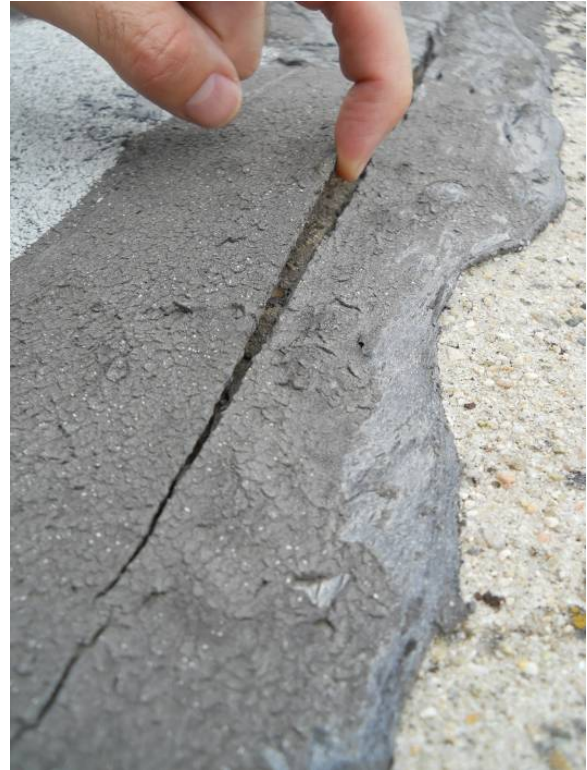
Cracks in rolled roofing membrane on top of middle roof parapet

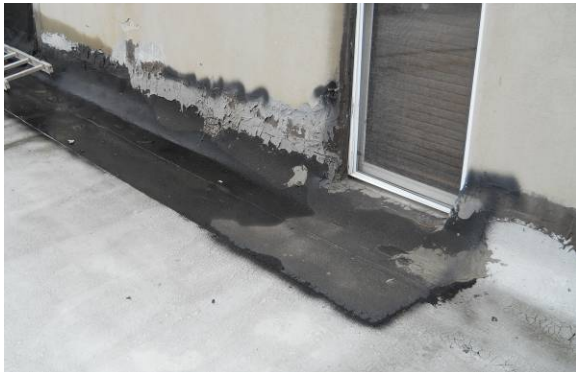
Middle roof: no continuous horizontal flashing, irregular existing caulk joint condition, multiple patches

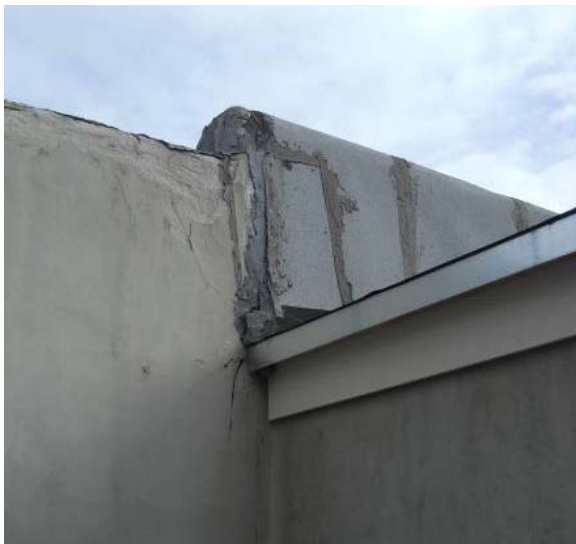
Middle to North roof: multiple patches, improper vertical flashing

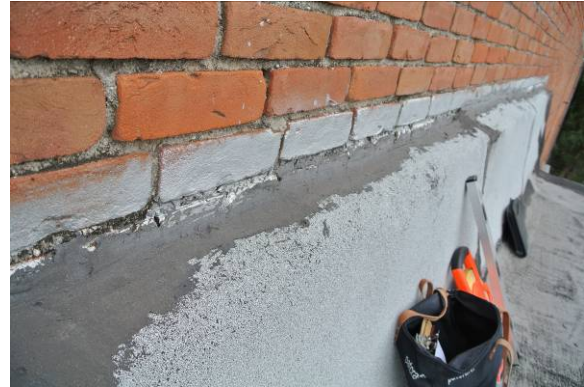
Middle roof: no continuous horizontal flashing against brick wall of south roof, irregular roof terminations provides opportunities for precipitation to infiltrate

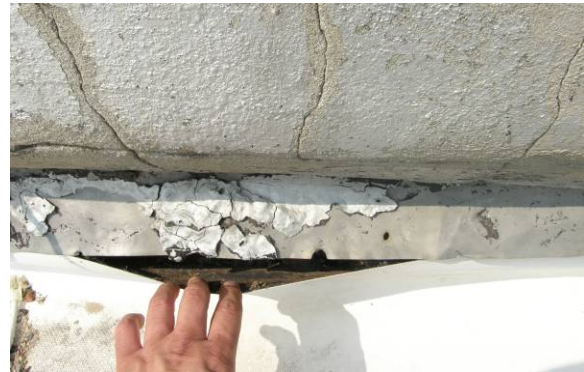
South roof: roofing membrane is not securely attached, existing metal flashing needs replaced, allows water and debris infiltration

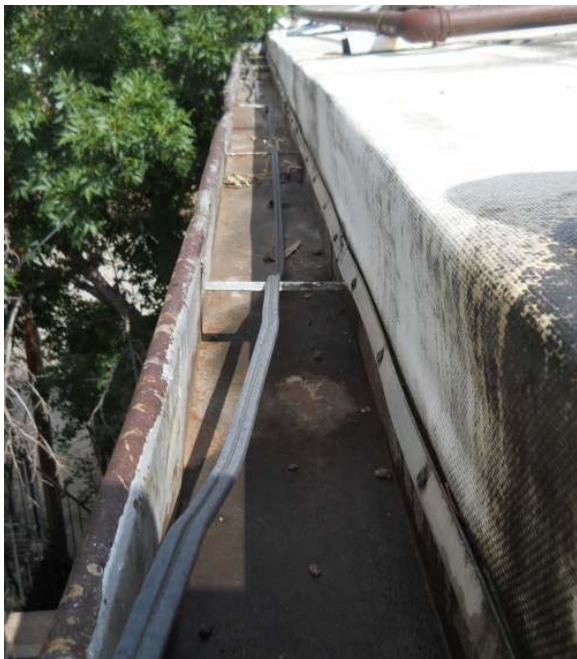
Gutter on south roof showing offset between top of roof and top of gutter (middle and north roofs are similar)

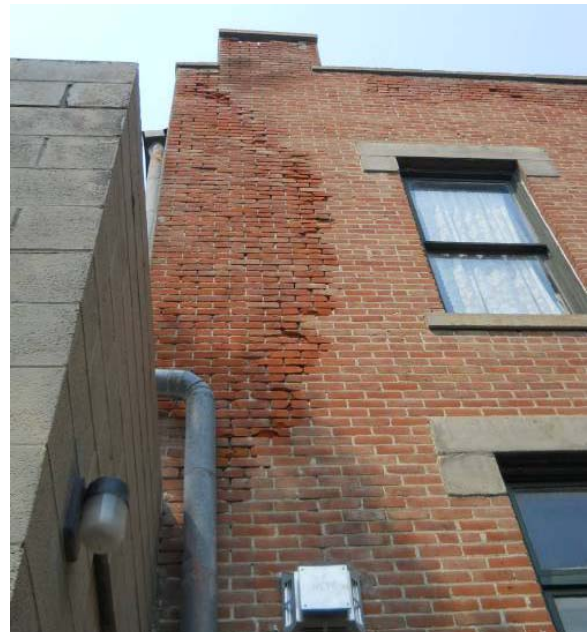
Large area of brick mortar erosion on southwest corner of south building

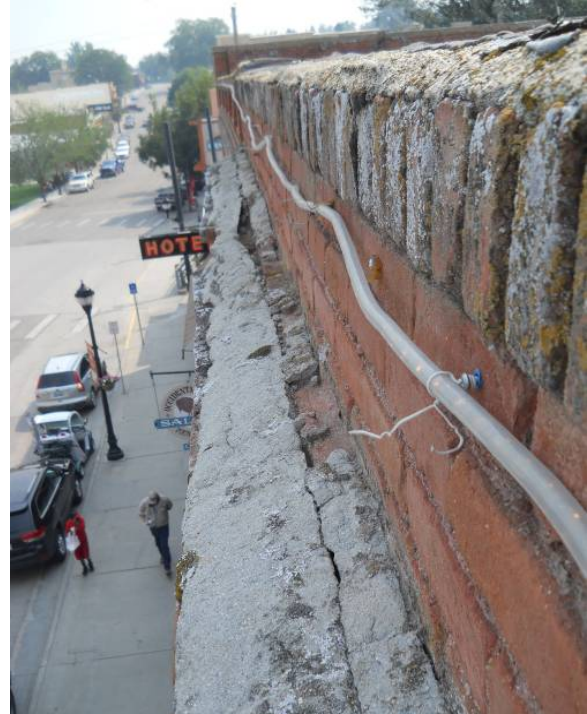
North building cornice: grout cap on cornice failing

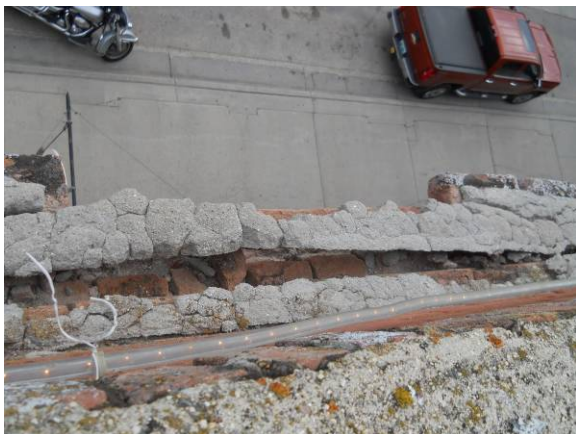
North building cornice: location where water had damaged grout and mortar of brick below, multiple bricks missing from ledge

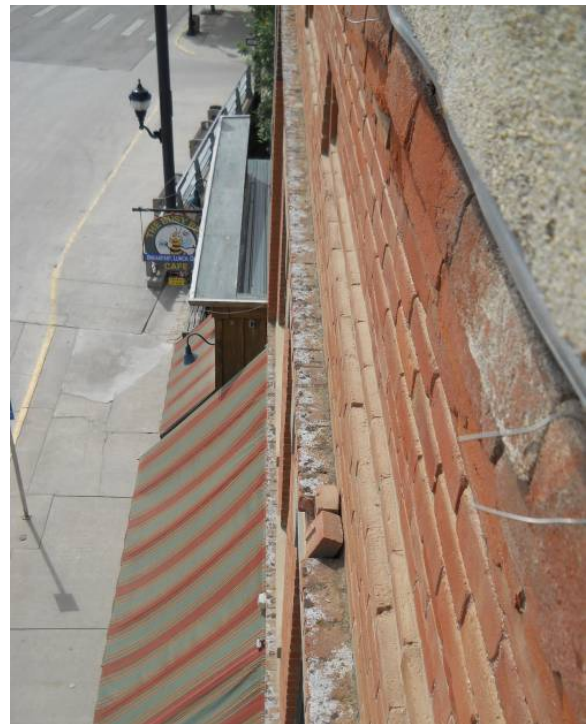
South building cornice: (middle building is similar), grout cap worn away and bricks becoming disturbed from water infiltration

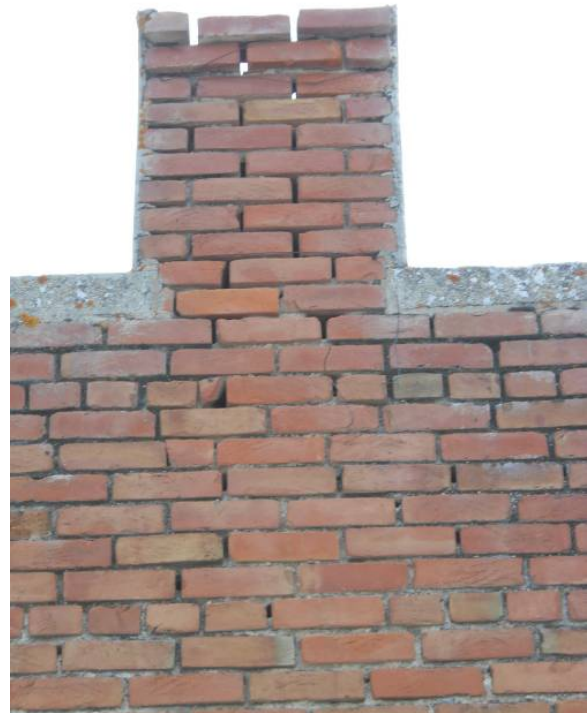
Chimney on north wall of south building showing fully eroded mortar joints exposing daylight

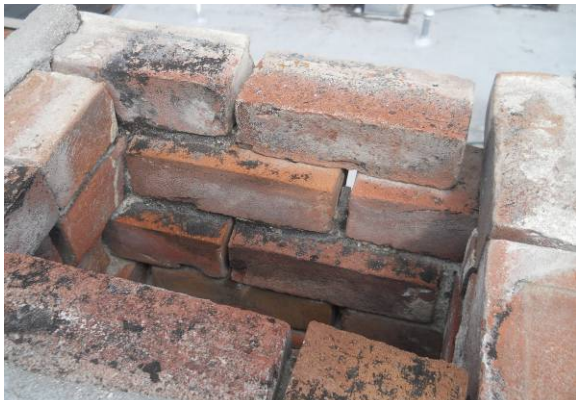
Typical chimney showing missing concrete cap, missing mortar joints, and loose bricks

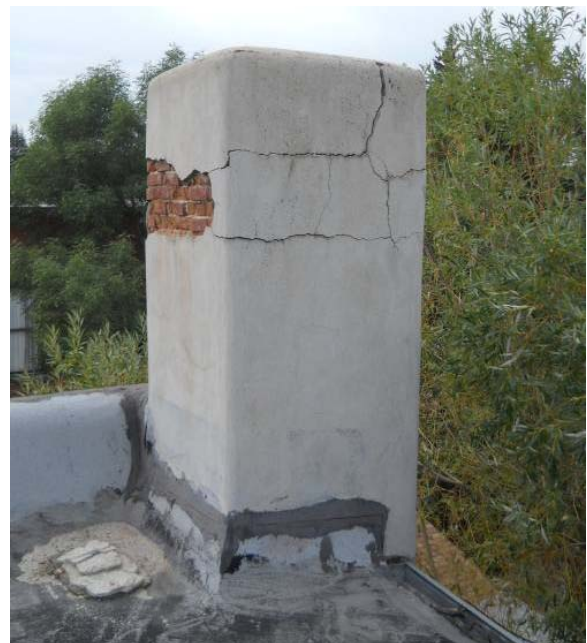
Chimney on southwest corner of north building showing signs of water infiltration through exposed inside and working its way through mortar joints and stucco to the outside

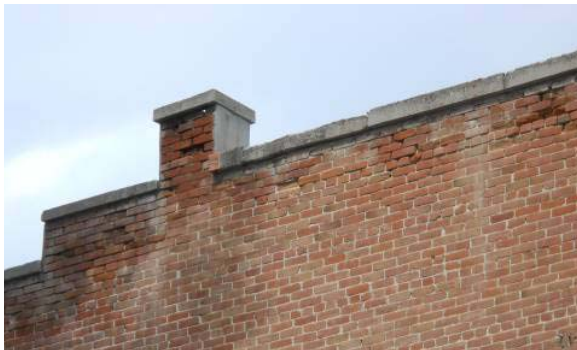
South facade showing deteriorated mortar joints and brick due to failing parapet joints, also showing water marks running down facade from joints

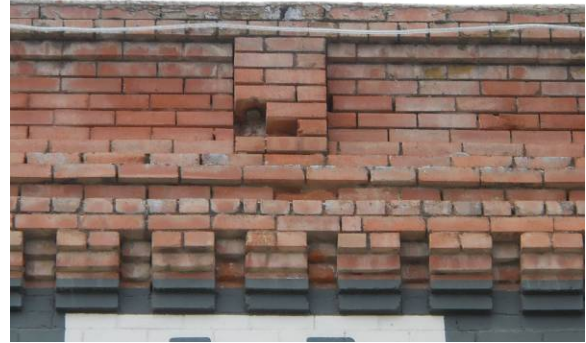
Upper portion of east facade, middle building showing eroded mortar joints and missing bricks

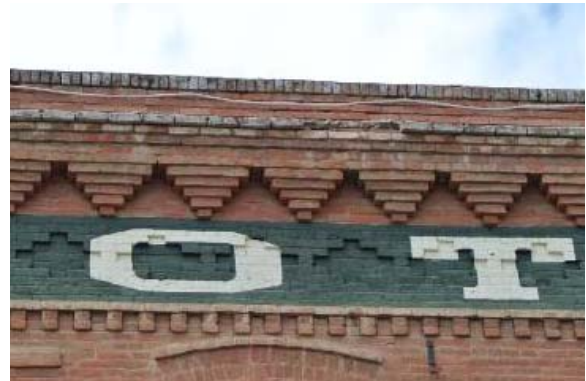
Upper portion of east facade, north building showing deteriorated mortar joints and brick

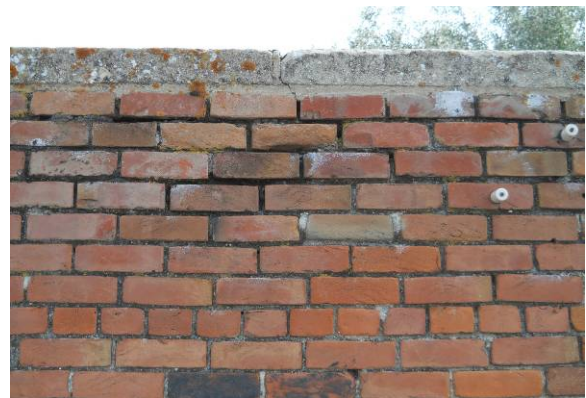
North facade of south building showing mortar joints eroded by failing joint in concrete parapet coping

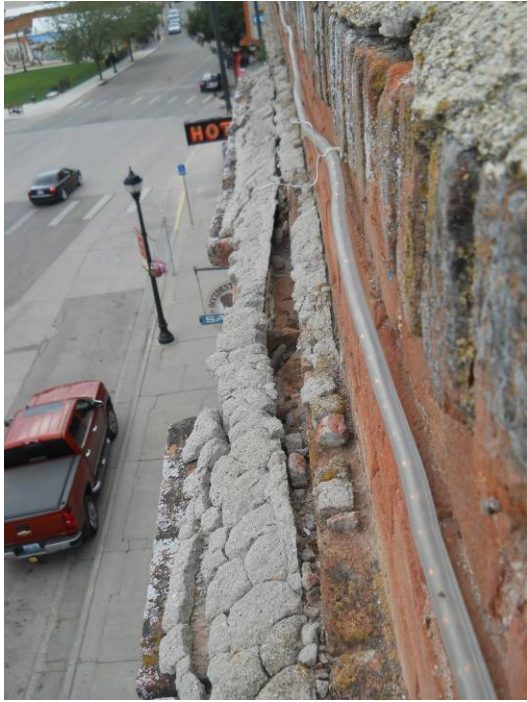
North building, deteriorating grout cap at brick cornices

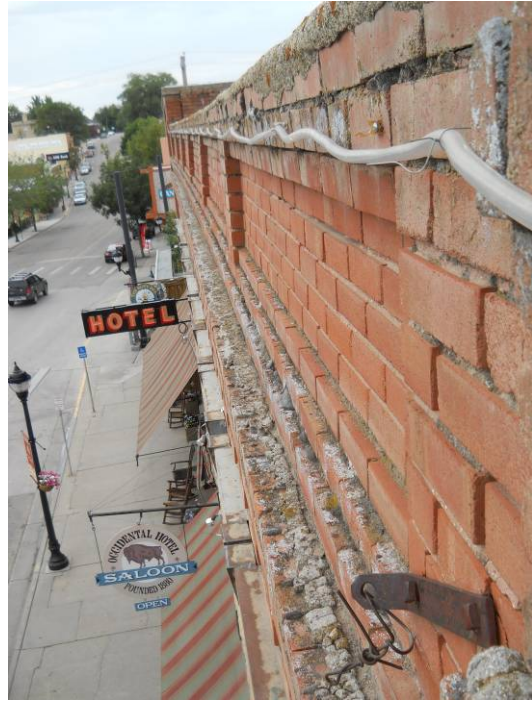
East building parapet/cornice face

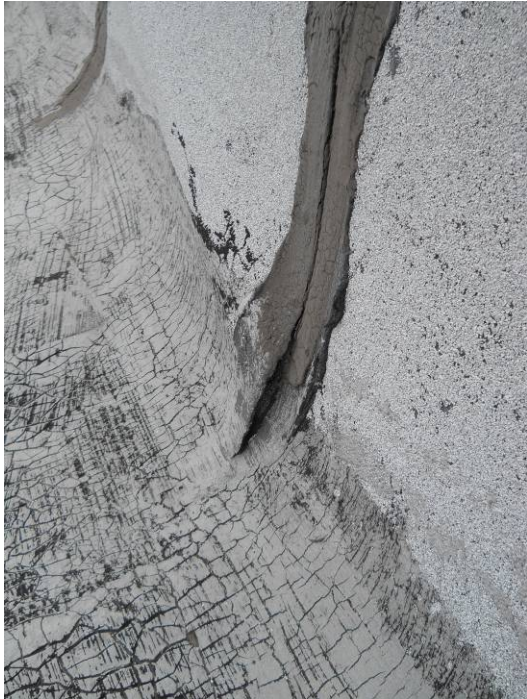
Typical cracking at seams in roof

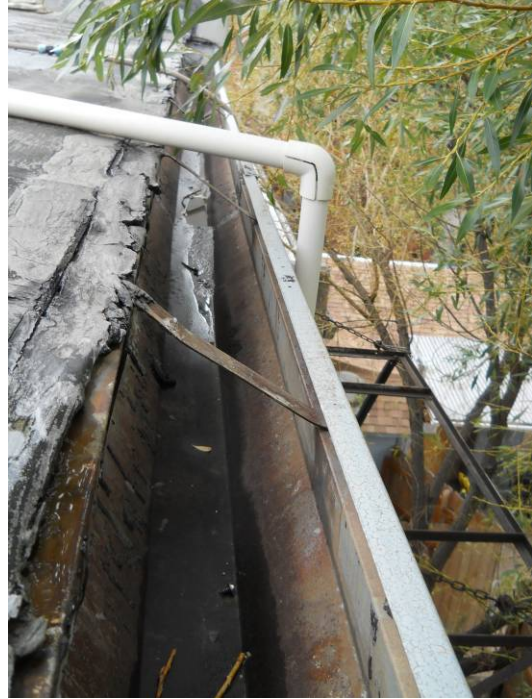
North building roof gutter

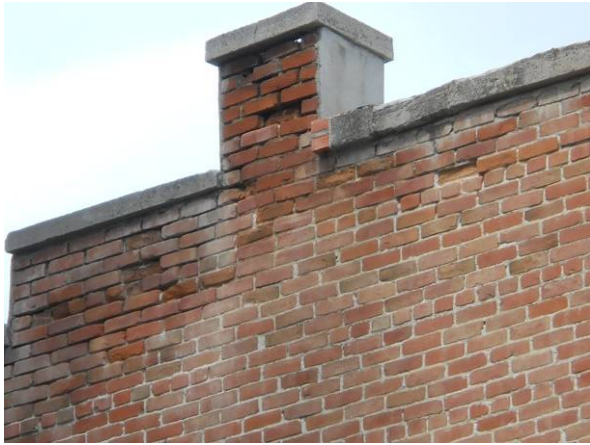
Typical brick and grout deterioration at south facade of south building

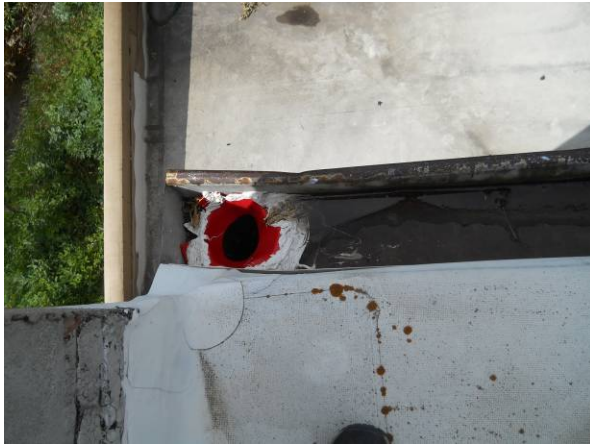
South building roof gutter/downspout connection
